U.S. Fish & Wildlife Service

Underground fuel release at Midway Atoll:

03/14/2003 Update

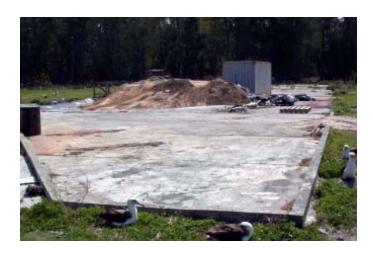
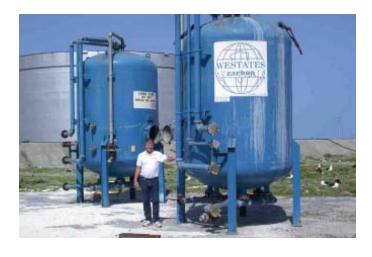
- As of March 13, approximately 33,500 gallons of JP-5 fuel have been recovered. With existing equipment, we are averaging about 650 gallons of fuel recovered per day.
 - The underground plume of released fuel appears to be localized and is not spreading. Its outer edge is approximately 800 feet from the lagoon at its closest point. The plume itself measures about 150 feet by 270 feet. Three monitoring wells have been installed just outside the JP-5 plume to detect any movement of the fuel. Underground piping systems are being monitored to ensure no fuel is moving into these pipes.
- A new lined soil remediation site has been established. Excavated soil will be spread at this site and regularly raked to aid the evaporation of the fuel.

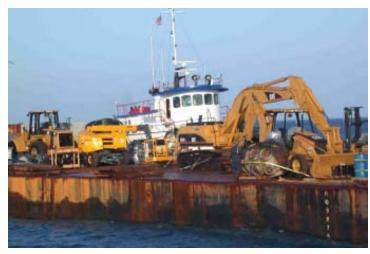
A barge bringing six new pieces of heavy equipment and supplies left Honolulu on March 7 and arrived at Midway on March 16. This equipment will allow FWS to excavate additional wells and to fully implement the fuel remediation program.
